Manhole Inspection Summary

Manhole # S17GG1006MH

Insp Date: **4/3/07 1:24 PM**

Location Address: **4017 GREENSPRING AVE**

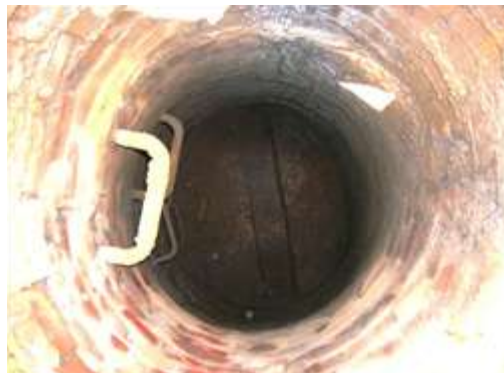
Top View

Corroded steps. Bench and Channel debris.

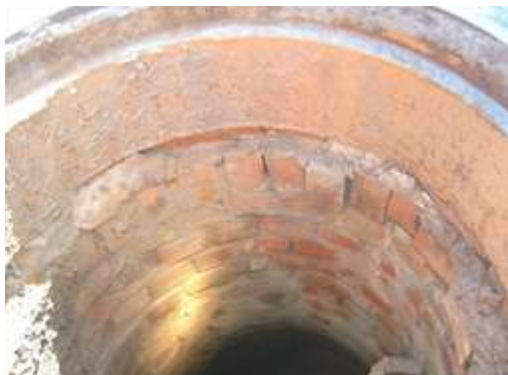
Defect

Frame leaks. Frame offset. Adjustment deterioration, loose brick and infiltration. Corbel and Barrel infiltration - other side.

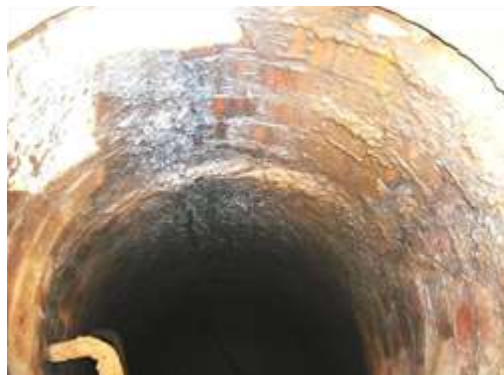
Defect

Frame leaks. Adjustment, Corbel and Barrel infiltration.

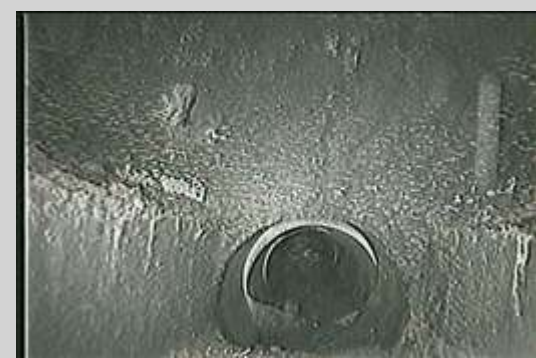
8 in. Circular Gravity Sewer Pipe Out @ 12 O'Clock

Deposits: ☐ None ☒ **Mud** ☐ Sludge ☒ **Debris** ☐ Grease

Silt Depth: **0.5** (in.) Deposits Extent: **Light**

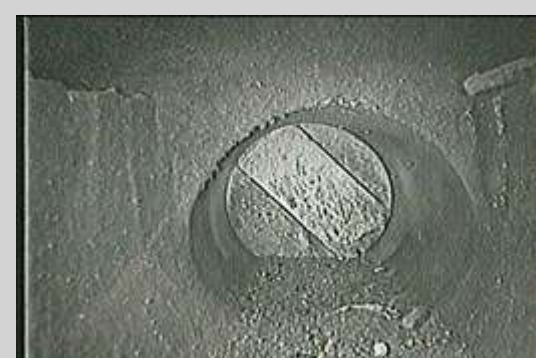
8 in. Circular Gravity Sewer Pipe In @ 6 O'Clock

Plugged.

Deposits: ☐ None ☒ **Mud** ☐ Sludge ☒ **Debris** ☐ Grease

Connects To: **Stub connection / abandoned**
